Manhole Inspection Summary

Manhole # S15EE1008MH

Insp Date: **6/20/07 9:05 AM**

Location Address: **2601 SHIRLEY AVE**

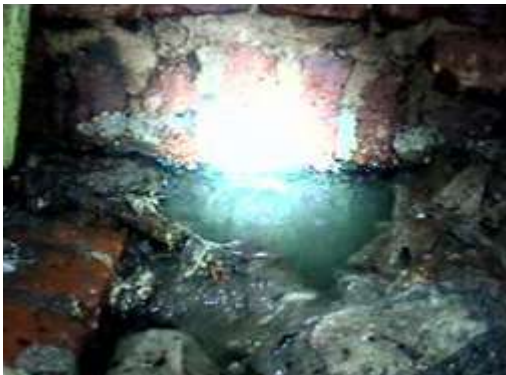
Defect 2

Condition: ☐ Sound ☐ Cracked ☐ Root Intrusion ☐ Deteriorated ☐ Leaks ☒ **Debris**

DEBRIS IN CHANNEL

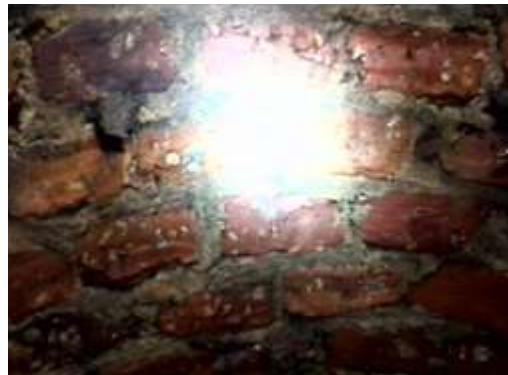
Defect 1

Count: **4** Missing: **1** ☒ **Corroded**

MISSING/ CORRODED RUNG

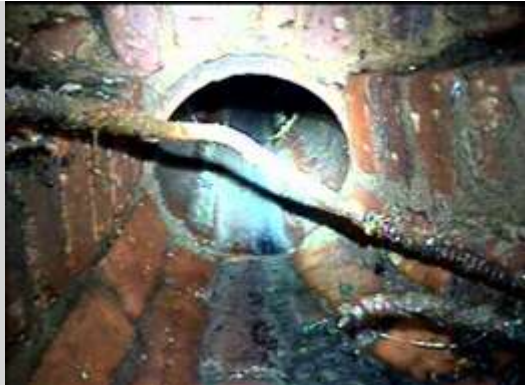
12 O'Clock Outflow

DEBRIS IN CHANNEL

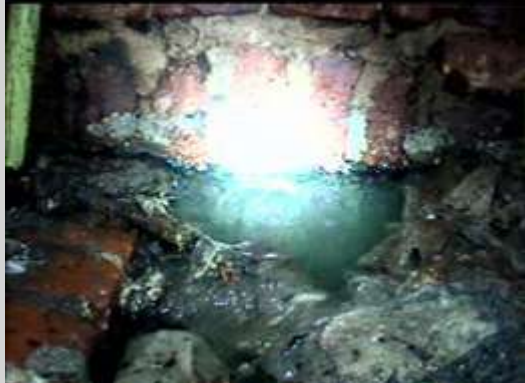
6 O'Clock Inflow

DEBRIS IN CHANNEL AND ON BENCH.

Deposits: ☐ None ☐ Mud ☒ **Sludge** ☒ **Debris** ☒ **Grease**

Silt Depth: **4** (in.) Deposits Extent: **Medium**
